MTL-TR-86-15  
ADA169355

# MECHANICAL TESTING OF A COATED CARBON/CARBON COMPOSITE AT ELEVATED TEMPERATURES IN AIR

GEORGE D. QUINN and JACOB J. STIGLICH, Jr.

May 1986

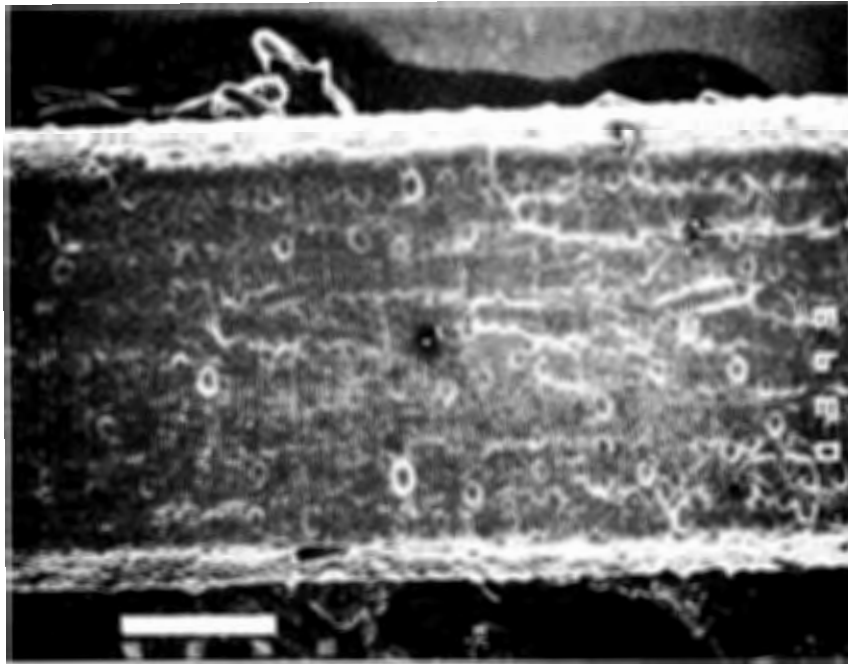
a. Viewing direction  $\parallel$  to cloth plies, bar = 1000  $\mu\text{m}$

b. Viewing direction  $\perp$  to cloth plies, bar = 100  $\mu\text{m}$

Figure 2. SEM photos of the surfaces of a coated bar.

The coating system was applied to two groups of 50 specimens at a time using SiC pins to hold them during deposition. Another 30 specimens were coated all over without using the pins, which are inconvenient and have been observed to lead to failure during oxidation testing. These had a 1/8"-diameter hole in the substrate end, through which a wire was used to hold the specimen in the deposition apparatus. The specimen-to-specimen coating thickness (interlayer plus overcoat) varied between 0.005" and 0.014". The variation in the thickness of the coating on an individual specimen was 0.002" to 0.004". The coating cross-section dimensions were measured on all specimens to estimate the coating stresses. The typical shape, dimensions, and appearances of the specimens are shown in Figure 1. The roughness of the substrate is generally replicated by a CNTD deposit unless a concerted effort is made for elimination it. Much work on substrate surface grinding would have been needed to improve the coating surface morphology. Figure 2 shows the SiC layer had cracks and was not continuous.

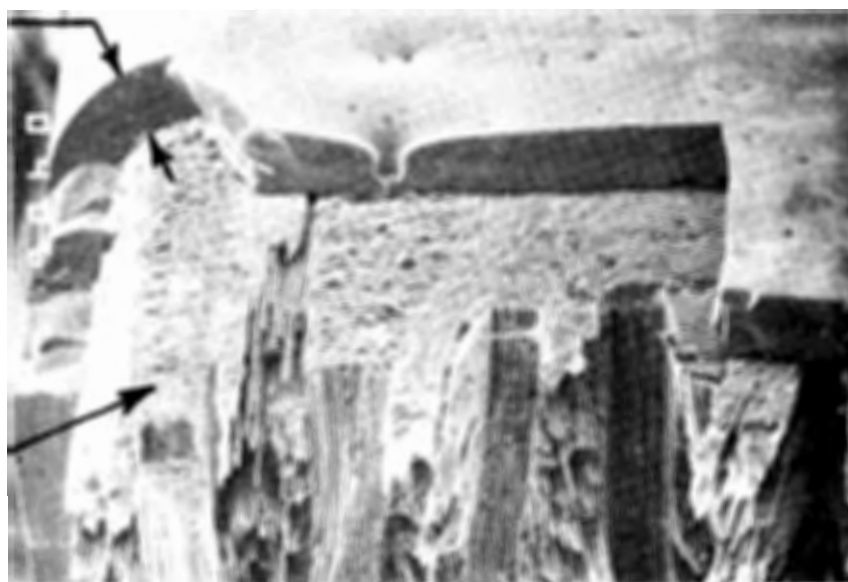
a. Fracture surface showing delaminated and pulled-out C/C plies. Direction of applied loads is indicated by arrows, bar = 1000  $\mu\text{m}$ .

b. Corner of same specimen illustrating the duplex nature of the coating system, bar = 1000  $\mu\text{m}$ .

Figure 9. A coated bar after room temperature flexure testing with load applied parallel to C/C plies resulting in a clean break through the section.

Figure 8 shows a typical fracture specimen, wherein the load was applied perpendicularly to the C/C plies. All of the data presented in this report are for bars tested in this fashion. Figure 9, in contrast, shows a specimen broken with the C/C plies parallel to the applied load, which resulted in a simpler fracture clearly revealing the composite beam structure.
